Stuck in Reykjavik

When the pilot of a round-the-world flight found himself AOG in Iceland with electrical issues, remote diagnosis saved the day.

by MIKE BUSCH

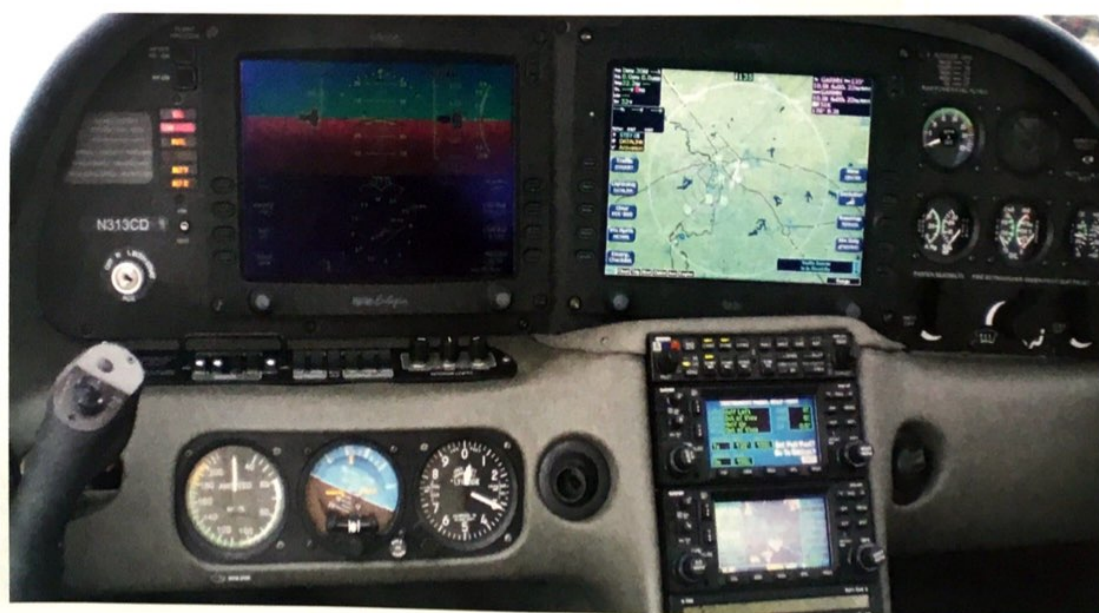
N313CD's panel shows the redundant and complex electrical system, employing dual batteries, dual alternators, and seven busses, all controlled by a complex MCU.

The electrical system of the 2004 SR22 is redundant and complex, employing dual batteries, dual alternators, and seven busses, all controlled by a complex master control unit (MCU). The local mechanics at Reykjavik – none of whom had any Cirrus-specific training or experience – performed basic functional checks on both batteries and both alternators and reported that they all seemed to be working properly. They could not account for the low E-BUS voltage alarm on the MFD, and suspected some sort of MCU problem.

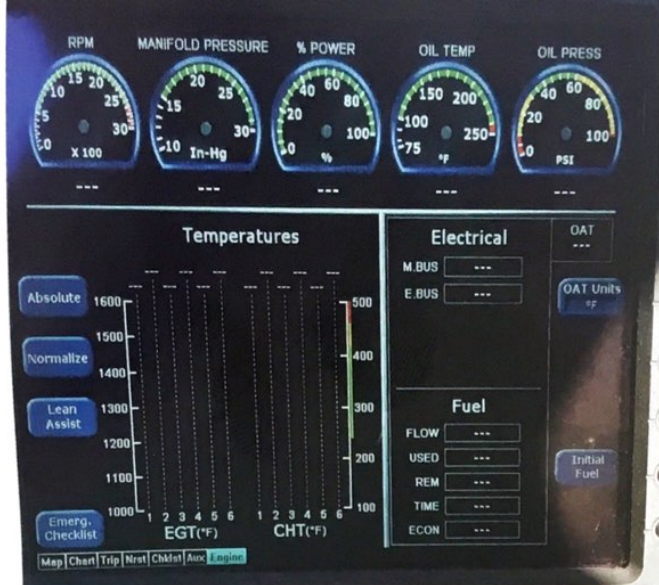
On the flight to Scotland, all the readouts on the MFD Engine/Electrical page were replaced by hyphens, just as predicted.

I could not go to bed without saying a massive thanks to both of you. Jeff said it all when I asked him what was the worst that could happen. He said I might lose all my digital readouts. That's exactly what happened just 40 minutes into the four-hour leg from Iceland to Scotland. Knowing that this could happen, I was prepared for it, did not panic, and simply reverted to using the steam gauges as if I was flying my good old Cessna. I made it safely to Scotland, and I will have the SIU looked at when I get to London. Once again, I thank you.

Lola's email was accompanied by a photo of his MFD Engine/Electrical page showing all the readouts replaced by hyphens (see photo on opposite page).
