## Pi in the Sky – Savvy Analysis Puzzler March 2017

Posted on March 17, 2017 by Joe Godfrey

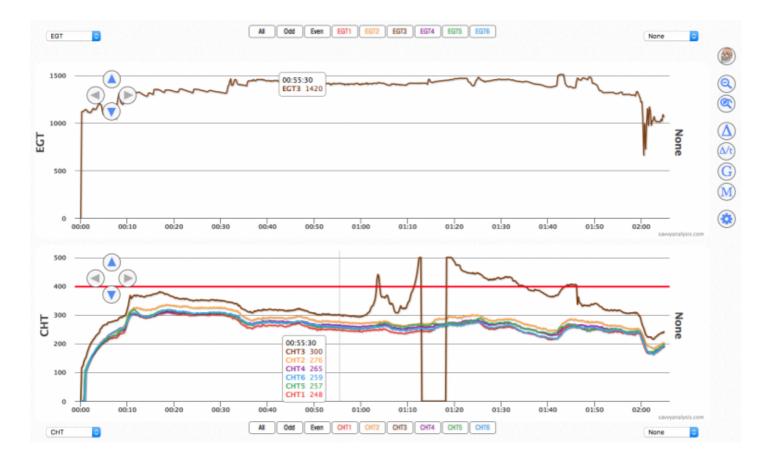
First up is data from a Cirrus SR-22 with a normally aspirated Continental IO-550-N. Data is from an Avidyne with a 6 sec sample rate.

All EGTs were logged, but I isolated EGT 3 so it would be easier to track along with CHT 3. Let's stipulate that EGT 3 tracks normally with other EGTs and is right in the middle of the pack throughout the flight. The higher numbers for CHT 3 happen not long after engine start, and its heat profile is different from its neighbors – about 50° hotter than the rest at takeoff, but still under 400°. Based on that higher CHT, and with normal EGT 3, your decision to come back and land versus press on probably depends on weather, and the importance of the trip and lots of other variables. But it has your attention.

At about the 20 min mark you level off and CHT 3 is high, but behaving. EGT 3 is still normal. I moved the cursor to the left of the anomaly so the pop-up box didn't obscure the pattern. Just after the one-hour mark, CHT 3 starts an almost-vertical rise, only to peak, fall and rise again – and this time it defies the laws of thermodynamics. The pattern looks like an upsidedown Pi- with a tail. At this point you should pretty much ignore anything CHT 3 has to say.

In the EGT 3 trace, you can see a couple of moves that suggest the pilot was changing power and fuel flow to get CHT 3 to act rationally, but it continues to track high until shutdown.

We're not ready to make an assertion, but let's just say it's not surprising to see a CHT probe failure at about an hour into the flight. Time will tell if that's a reliable pattern.

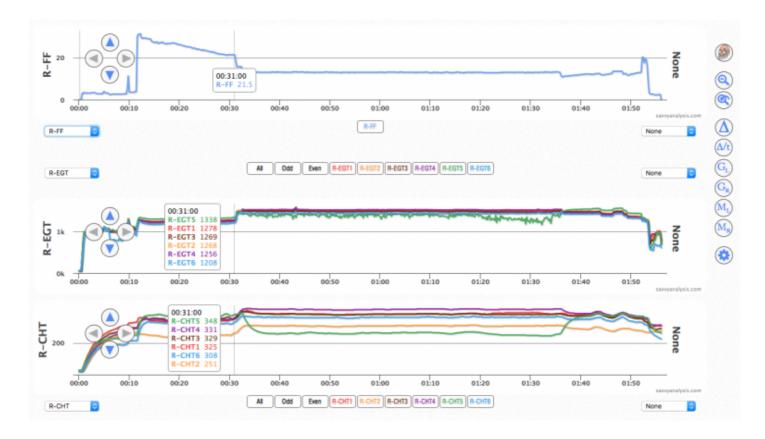
Next up is data from a Beech Baron 58 with Continental IO-550-N engines. Data is from a JPI 760-twin with a 2 sec sample rate. Normally we'd see L engine data on top and R engine data on bottom – I changed the top graph to display R engine FF.

CHT 2 – the gold trace – is using a spark plug gasket probe, so we expect to see lower CHTs. Aside from that all looks ok except EGT and CHT 5. They're high when FF is high, then at the big pull (at the cursor) CHT 5 drops dramatically and EGT 5 becomes jittery.

If you're a regular Puzzler reader, you have probably spotted this scenario as a textbook clogged injector. Clogged enough to pass most – but not all – of the fuel when there's a lot of it, and barely able to sustain combustion when fuel is scarce. When FF is reduced from the cruise setting – at about an hour and 35 mins in the timeline – that seems to be the magical amount where the clog is no longer a factor.

So if you're in cruise and suspect a clog, it's counter-intuitive to think you should reduce FF a skosh, but – depending on the nature of the clog – it could make a difference.

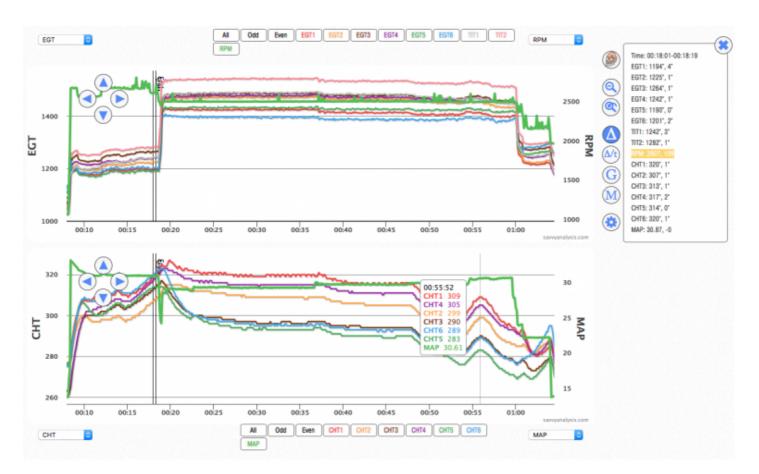
Next up is data from a Cirrus SR-22 with a Tornado Alley IO-550-TN. Data is from an Avidyne with a 6 sec sample rate. EGTs and RPM are on top – RPM is bold and green. CHTs are on bottom, along with MAP which is also green.

This isn't the entire flight – I zoomed in to show takeoff to approach. The data shows momentary spikes in RPM. The pilot saw the spikes in real time, but felt no surges or change in power when he saw them.

There's a box of numbers to the right of the top graph. I used our plotter's delta tool to measure the quantity of the spikes, and they were about 100 RPMs each time. Notice there are no spikes until the end of climb, then a few in the early cruise segment, then they get plentiful toward the end of the flight.

You would certainly feel a real surge of 100 RPMs, especially considering that with this 6 sec sample rate it would have had to last at least that long to get into the data. So in the absence of any corroboration, this looks like an RPM sensor on its way out. We always recommend checking connections before replacing sensors or probes, but the consistency of the spikes in the 100 RPM range seems too rational for a loose connection.

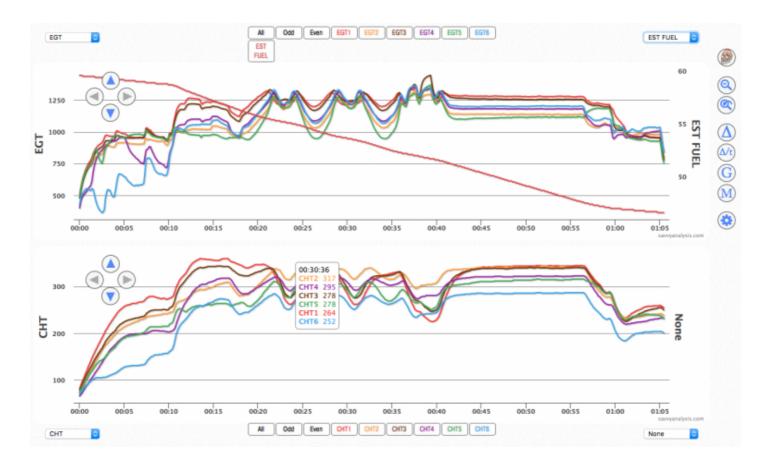
Let's finish this month with a puzzling scenario that the data helped solve. Here's data from a Cessna 180 Skywagon with a Continental O-470, using an EI MVP-50P with a 1 sec sample rate. The sloping red line is Estimated Fuel in Gallons – starts about 60, ends about 40.

The pilot reported that when he topped off, the panel-mounted fuel gauges read accurately, and as he flew, those gauges showed that he was using more fuel than the engine monitor showed. For instance, he'd top off, reset the EI, fly for an hour with FF around 12-14 GPH, his gauges showed about half-tanks, but the EI showed him down about 12-14 GPH. The longer he flew, the closer to E his gauges would read. If he landed and topped-off, the pump showed 12-14 GPH and the gauges read F again.

So the data showed that the EI was accurate, and the panel-mounted gauges were reading ok when full, but progressively lower as fuel was consumed. Hint – this 180 uses bladder-type tanks.

A very determined avionics tech opened the fuel bladder to check the sensors, and discovered that the snaps holding the bladder on the top of the wing, above the fuel sender, had disconnected. So as the fuel quantity decreased, the bladder collapsed over the fuel sender float pushing it down – resulting in an abnormally low indication.
